Chapter 1
General

This manual is designed as a training tool for operation of the PA-28R-200 Arrow training aircraft. However, it is not intended as a substitute for adequate and competent flight instruction, pilot knowledge of current airworthiness directives, applicable Federal Air Regulations (FARs) or Advisory Circulars (ACs). The manual is a procedural manual for operation of the PA-28R-200 Arrow when conducting flight training within the Bridgewater State College flight training program, and as such must be kept in current status.

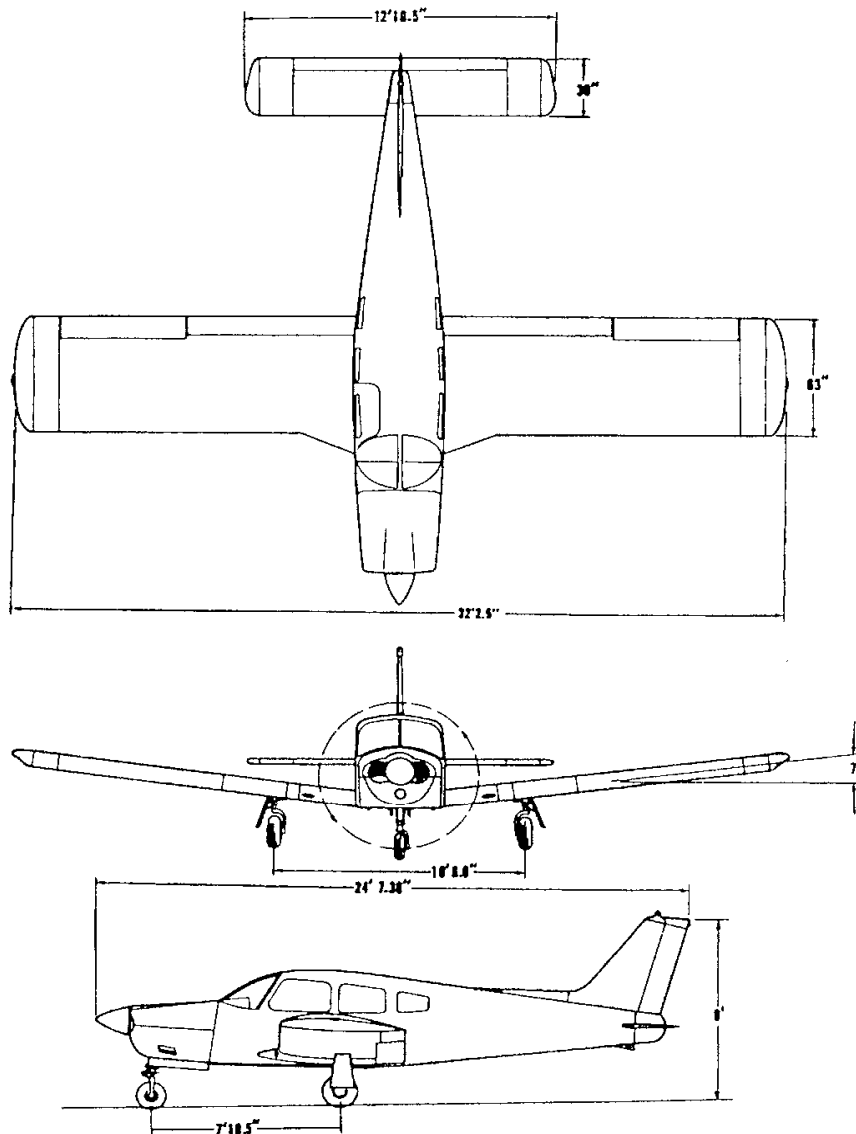
Figure 1-1
THREE VIEW DRAWING
(Not to scale)

This chapter includes depictions of the aircraft and its basic dimensions. These depictions are printed here by permission of Piper Aircraft, Inc., and may not be reprinted or copied without written permission from Bridgewater State College Aviation Operations and Piper Aircraft, Inc.
